# Developing an Understanding of Variables that Impact on Unknown-to-Detonation Transitions (XDT) in GAP/Nitramine Propellants

Ben Keefe – [Benjamin.Keefe100@mod.gov.uk](mailto:Benjamin.Keefe100@mod.gov.uk)  
Dr Jocelyn Peach – [Jocelyn.Peach108@mod.gov.uk](mailto:Jocelyn.Peach108@mod.gov.uk)  
DOSG Science & Technology – Energetics Vulnerability  
Insensitive Munitions and Energetic Materials Symposium – Seville, 2019

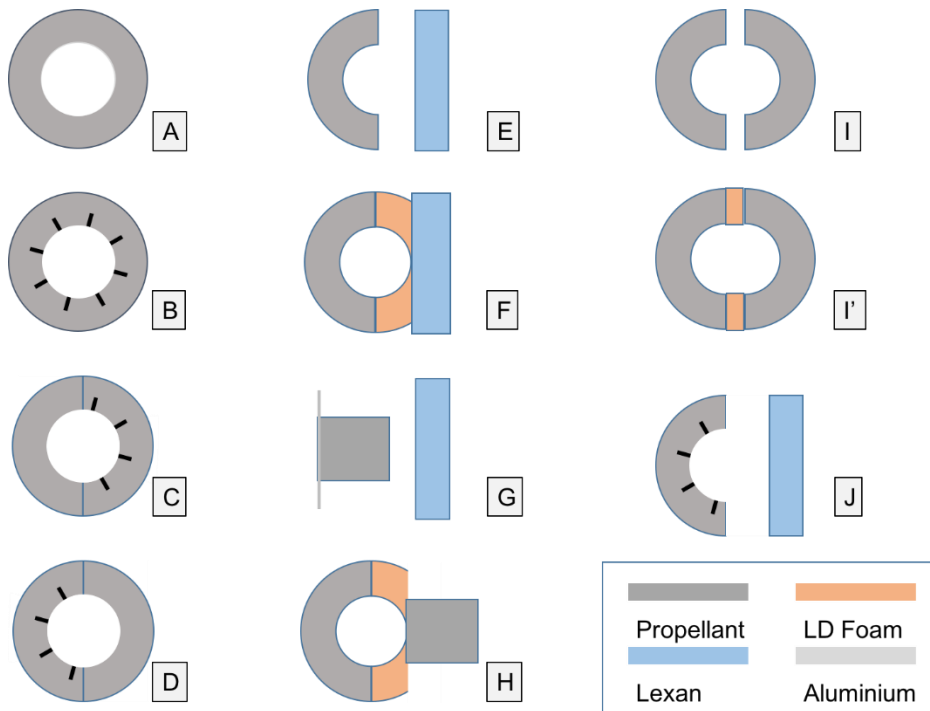
# Trials Programme

Target Type	Notes
A	Plain smooth-bore motor section, 60 mm long
B	Stellated-bore motor section, 60 mm long
C	Smooth-bore half section at the impact side, and slotted half-section downstream
D	Slotted-bore half-section at the impact side, and smooth half-section downstream
E	Smooth-bore half-section at impact side, and inert Lexan plate downstream. The separation between the Lexan plate and the half-section was 15, 30 and 45 mm
F	Smooth-bore half section at impact face and Lexan back plate. In-fills used to simulate an inert down-stream section of the same bore diameter as the live motor
G	Aluminium cover plate 6 mm thick at impact face, in contact with a solid cylindrical pellet (cylindrical axis in-line with impact direction) and with a Lexan plate downstream. The spacing between the rear face of the pellet and the Lexan plate was 20, 30, 35, 38, 40 and 63 mm
H	Smooth-bore half-section at impact side, with in-fill inert simulated bore, backed by a solid cylindrical pellet

I	Smooth bore half section at impact side, with smooth-bore half section at the downstream side, separated by an air gap of 5 mm
I'	Smooth bore half section at impact side, with smooth-bore half section at the downstream side, separated by a foam in-fill of 5mm thickness
J	Slotted bore half-section at the impact side, and Lexan inert plate downstream. The spacing between the Lexan plate and the impact section was 30, 45 and 60 mm

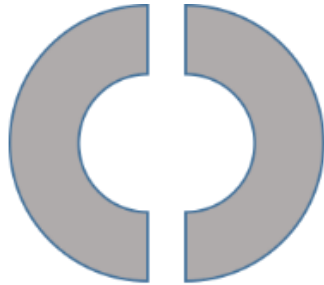
A

# Configurations that XDT

- Smooth bore internal towards when the fragment is striking
- Energetic impact surface

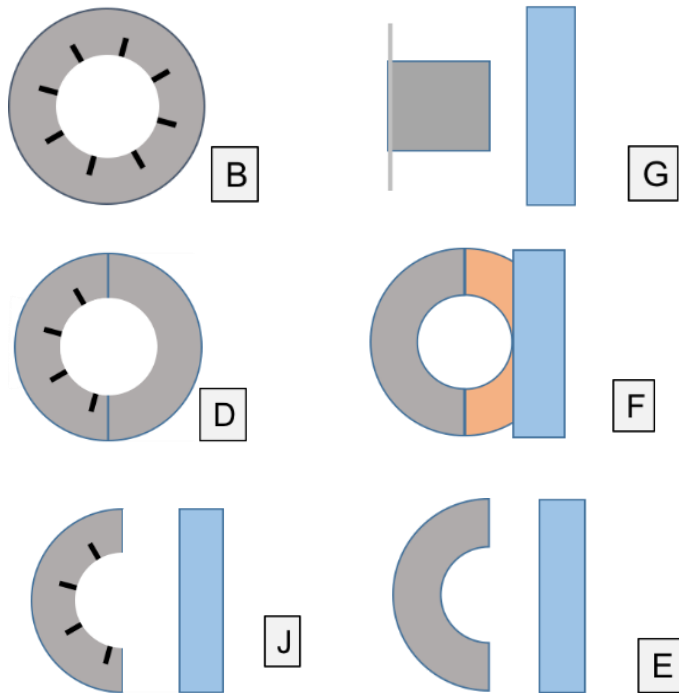
# Configurations that DO NOT XDT

Can broadly fit into two categories:

- Slotted bore internal towards when the fragment is striking
- Inert impact surface

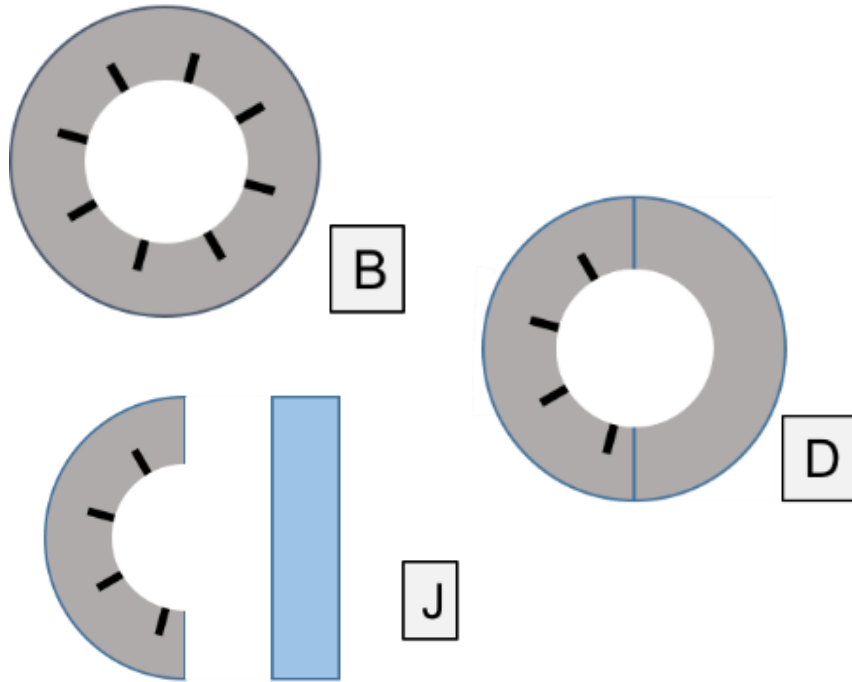
# Slotted Bores

- Slotted bore Rocket Motors do not appear to XDT
- Hypothesis – The jetting effect pre-ignites the ‘XDT cloud’ – meaning it has not developed the correct density for XDT to occur
- Previous work with this work seems to confirm this hypothesis

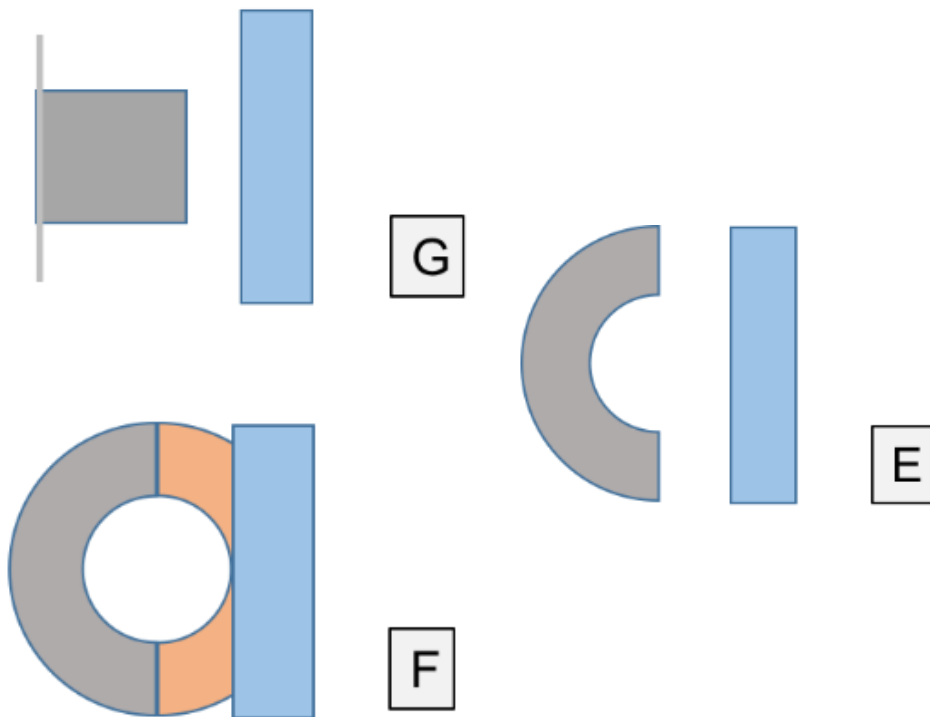
# Inert Impact Surfaces

- Hypothesis – XDT requires an energetic secondary surface for XDT to occur
- Previous work **DOES NOT** seem to confirm this hypothesis

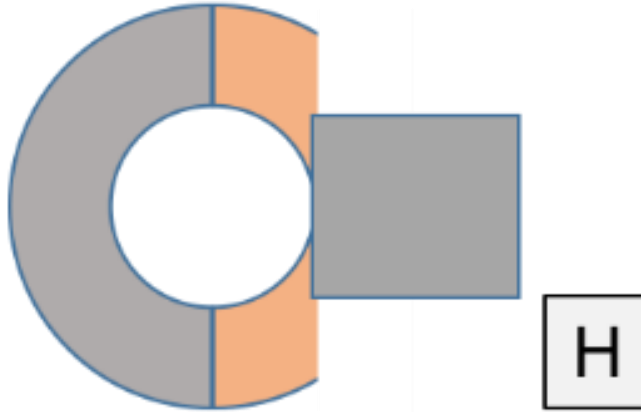
# 'Sore Thumb' Result

Has the exact same two features seen in the configurations that XDT:

- Smooth bore internal towards when the fragment is striking
- Energetic impact surface

**BUT DOES NOT XDT**

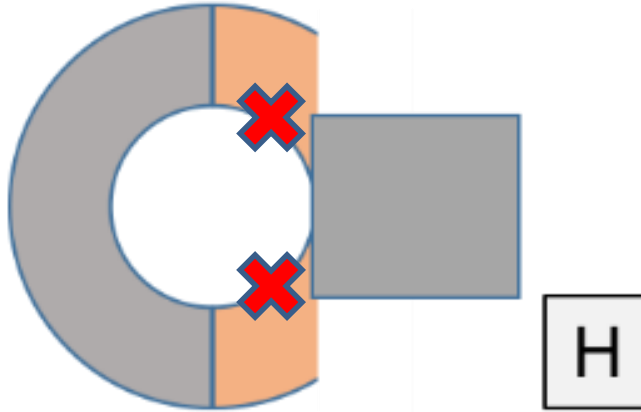
# New Hypotheses

So what could be happening? We have two ideas:

- The nitramine level could have an impact on whether a material with XDT with less material present
- The XDT does not happen directly and the base of the cloud – it could need to happen where the red 'X's are to the left
